ANNUAL REPORT FOR 2006

UT Town Creek Mitigation Sites Rowan County TIP No. I-2511CA

Prepared By:
Natural Environment Unit & Roadside Environmental Unit
North Carolina Department of Transportation
December 2006

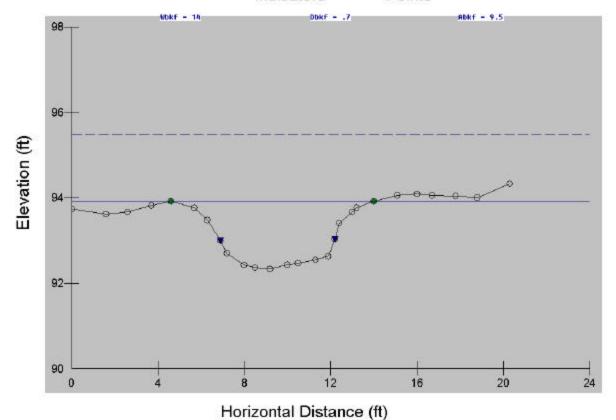
I-2511CA Site #5 XS-1 Pool

Site #5: Cross-Section #1 (Pool) Abbreviated Morphological Summary*				
	2006 2007 2008			
Bankfull Cross Sectional Area (ft²)	9.49			
Maximum Bankfull Depth (ft)	1.58			
Bankfull Mean Depth (ft)	0.68			
Bankfull Width (ft)	14.0

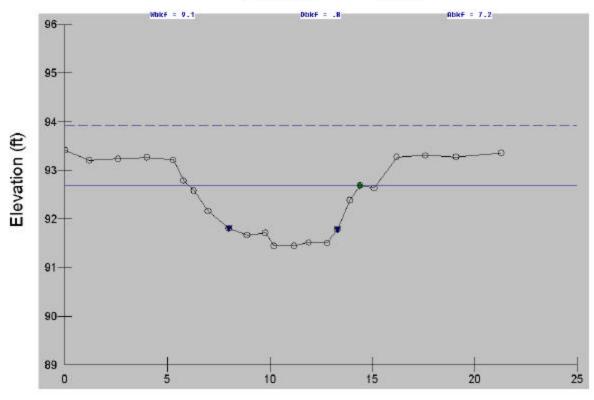
I-2511CA Site #5 XS-2 Riffle

Site #5: Cross-Section #2 (Riffle) Abbreviated Morphological Summary

2006	2007	2008
Bankfull Cross Sectional Area (ft²)	7.24		
Maximum Bankfull Depth (ft)	1.24		
Width of the Floodprone Area (ft)	34.6		
Bankfull Mean Depth (ft)	0.79		
Width/Depth Ratio	11.57		
Entrenchment Ratio	3.79		
Bankfull Width (ft)	9.14

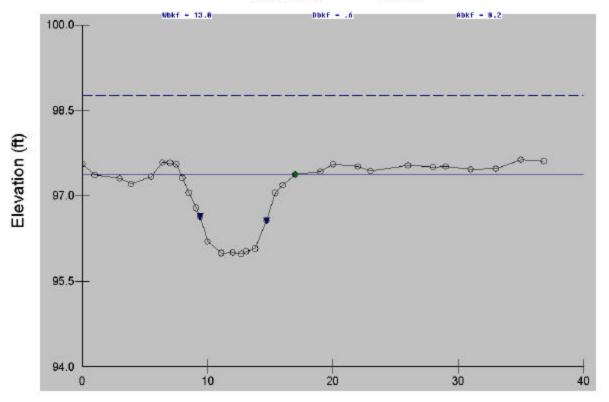
I-2511CA Site #5 XS-3 Pool

Site #5: Cross-Section #3 (Pool) Abbreviated Morphological Summary*				
2006 2007 200				
Bankfull Cross Sectional Area (ft²)	7.83			
Maximum Bankfull Depth (ft)	1.39			
Bankfull Mean Depth (ft)	0.86			
Bankfull Width (ft)	9.13

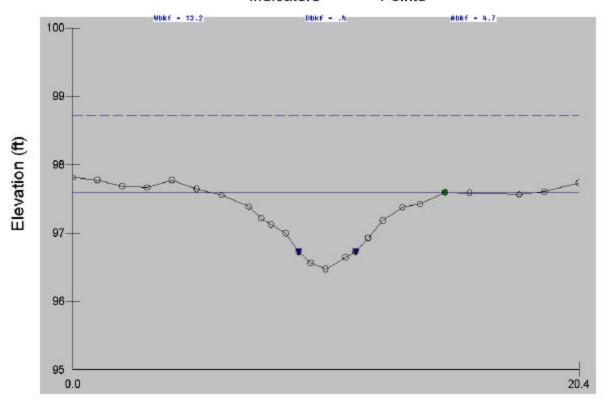
I-2511CA Site #5 XS-4 Riffle

Site #5: Cross-Section #4 (Riffle) Abbrevia	ection #4 (Riffle) Abbreviated Morphological Summary			
	2006	2007	2008	
Bankfull Cross Sectional Area (ft²)	4.65			
Maximum Bankfull Depth (ft)	1.12			
Width of the Floodprone Area (ft)	20.4			
Bankfull Mean Depth (ft)	0.50			
Width/Depth Ratio	19.27			
Entrenchment Ratio	2.16			
Bankfull Width (ft)	9.44

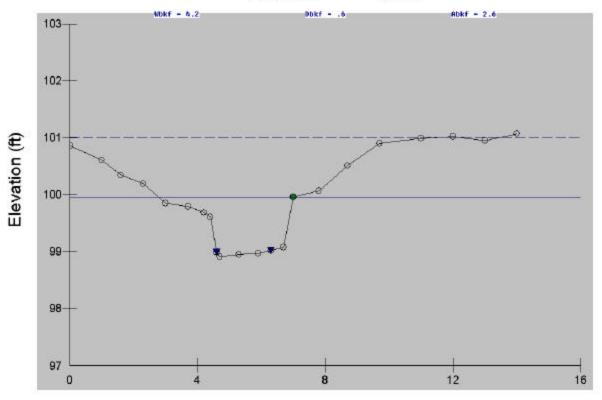
I-2511CA Site #8 XS-1 Riffle

Site #8: Cross-Section #1 (Riffle) Abbreviated Morphological Summary

2006	2007	2008
Bankfull Cross Sectional Area (ft²)	2.62		
Maximum Bankfull Depth (ft)	1.05		
Width of the Floodprone Area (ft)	13.02		
Bankfull Mean Depth (ft)	0.62		
Width/Depth Ratio	6.82		
Entrenchment Ratio	3.08		
Bankfull Width (ft)	4.23

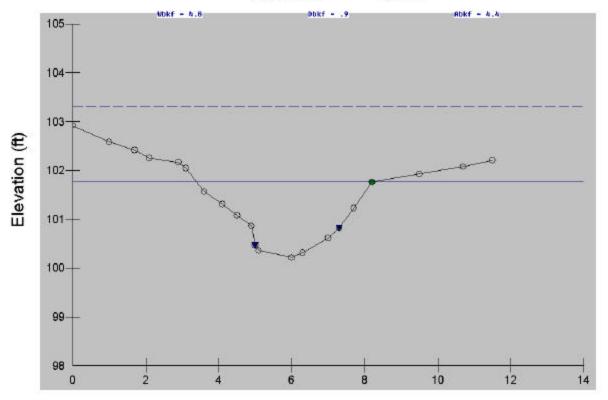
I-2511CA Site #8 XS-2 Pool

Site #8: Cross-Section #2 (Pool) Abbreviated Morphological Summary*			
2006 2007			
Bankfull Cross Sectional Area (ft²)	4.42		
Maximum Bankfull Depth (ft)	1.55		
Bankfull Mean Depth (ft)	0.92		
Bankfull Width (ft)	4.81
